Experimental Study of Failures of Air Conditioners System Tram in Desert Areas by Applying Preventive Maintenance (Using Reliability Lows)

K.Lemnaouer^{1*}, M.Louafi², Z.Aoulmi³, R.Karek⁴, M.Taleb⁵

Tob Regul Sci.™ 2024;10(1): 310 -329

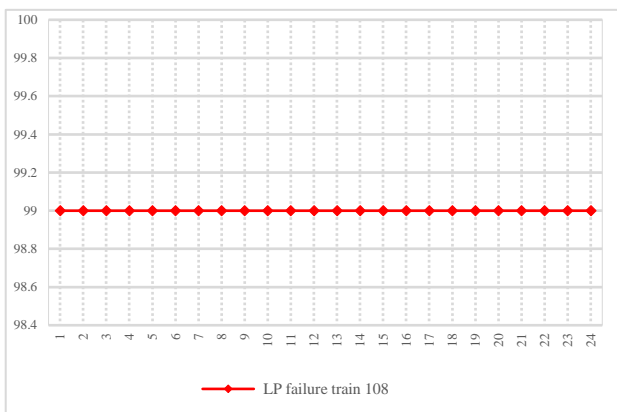
The failure of the low pressure LP valve is high in tram 108, train 108 will therefore be a battering ram to compare the results obtained in the rest of the tram. The results are represented in the following curves:

Fig. 12. Chart showing the percentage of LP failure in tram 108.

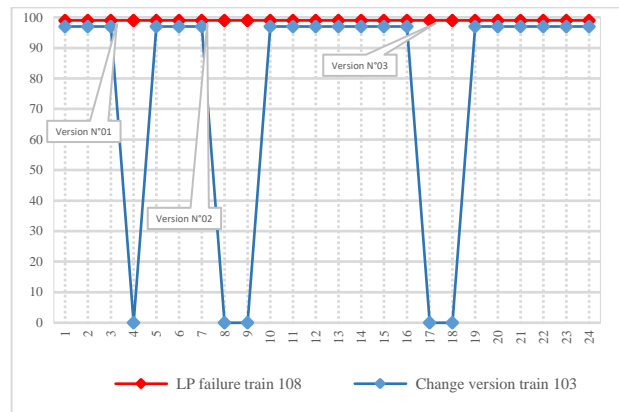
Fig. 13. Chart showing the failure rate of LP in tram 103 after changing the

Comparing the results of the three trains with train 108, we noticed that the LP failure disappears for only a few minutes when changing the three versions of car 103 and then reappears when the air conditioners are turned back on directly compared to cars 104 and 105 where we noticed that the fault disappears for a period of more than an hour when changing the

- Change the version of the air conditioning system of tram 103 (version 1, version 2, version 3)
- Change the solenoid valve of tram 104.
- Change the capacity regulator of tram 105.

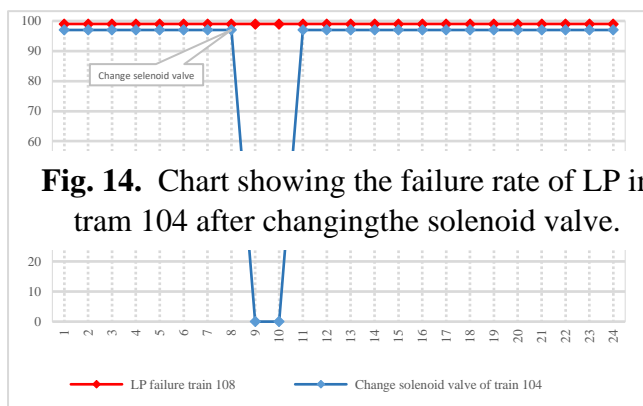
Fig. 14. Chart showing the failure rate of LP in tram 104 after changing the solenoid valve.

solenoid valve and the capacity regulator, but the fault appears again, and therefore all the operations are considered negative because the LP failure has not disappeared.

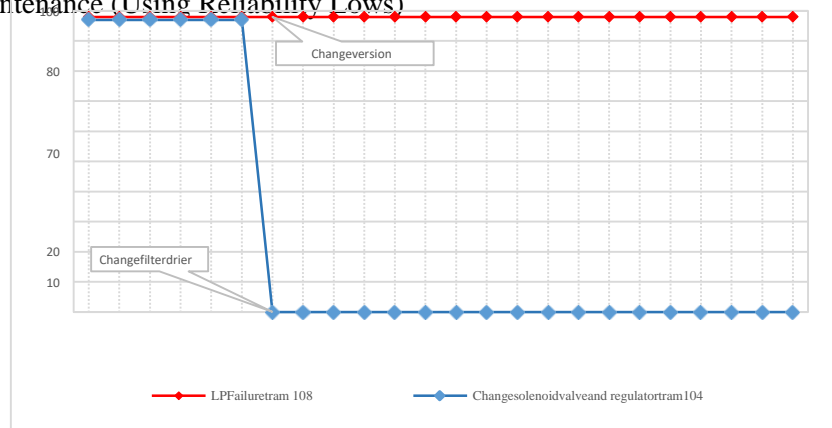
Fig.16.Graph showing the failure rate of LPintram104 after changing the filter drier.

Total disappearance of LP pressure failures on train 101 after changing the filter drier of circuit 2 and their persistence on train 104.

- Change the version of tram 104
- Replace the filter drier with the tram 101

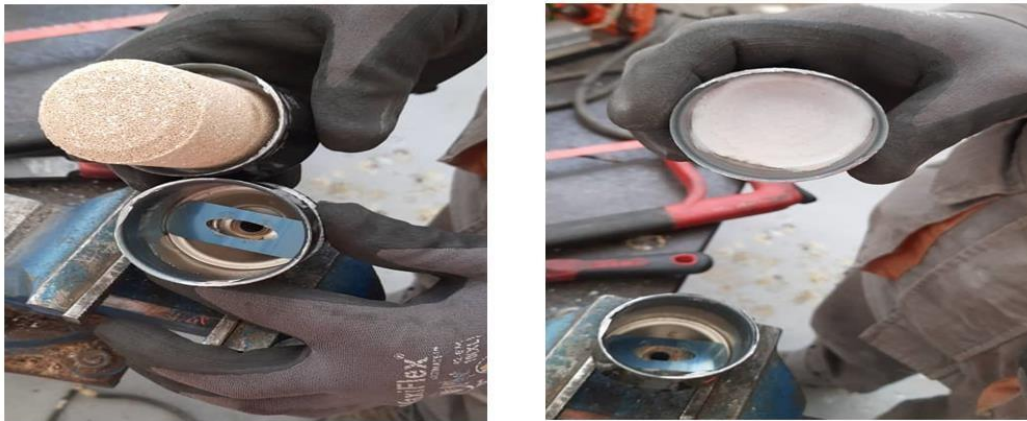
Fig.18.Picture for an internal section of the new filter drier

We notice in the photos that the inner cotton of the good filter is white in color and in good condition compared to the damaged filter, in which the inner cotton appears black and completely burned, forming a solid insulating layer for the liquid, and it is the reason for its blocking.

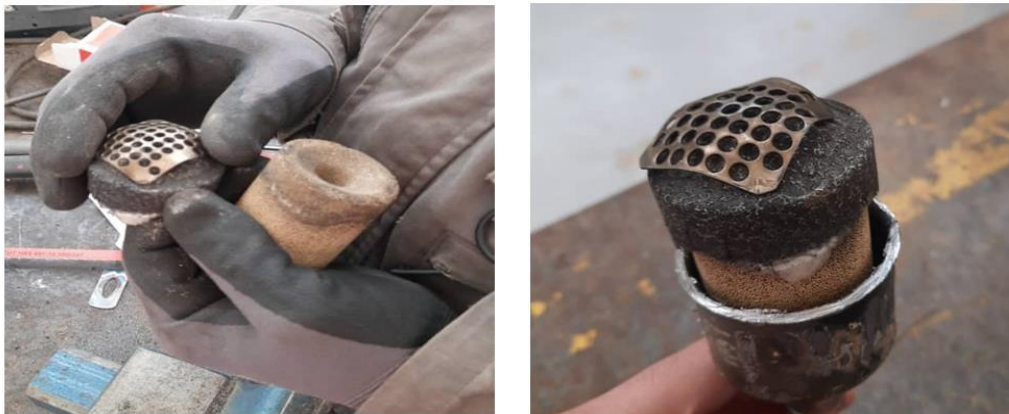
Fig.19.Photo of a damaged internal section of the filter drier

Having understood that the cause of the blockage is due to the melting of the cotton layer at the bottom of the dried filter, we can say that the cause of the melting is largely due to an error that occurred during the installation process of the filter. filter in circuit 2 of the air conditioning

- After identifying the main problem and its cause, the filters of all vehicles were changed using the correct welding method. The results are presented by the reliability rate after changing the filters as follows:

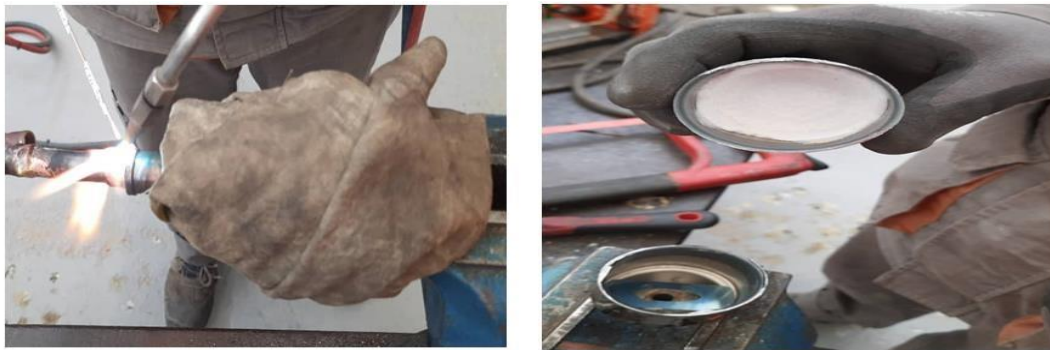
Fig.20.Photo of filter drier, (A) the correct welding method, (B) the inner part of the filter drier after welding

We can see from the photos that the Dreyer filter, which was soldered as recommended, remains healthy. As for the second filter, which was welded without respecting the recommendations, it was completely destroyed. The main reason for Drier filter clogging is the melting of the inner cotton layer due to incorrect welding method.

To confirm this, we welded two different filters, the first by welding respecting the recommendations attached to the filter drier (Fig. 20) and the second by welding without respecting the recommendations (Fig. 21). The results are shown in the photos.

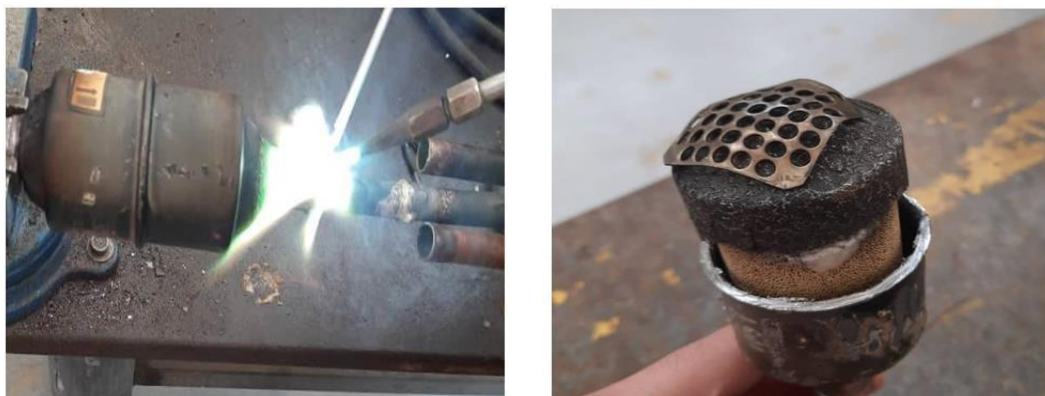
Fig.21.Photo of filter drier, (A) the wrong welding method, (B) the inner part of the filter drier after welding
